737

Service Bulletin

Number: 737-53A1251
Original Issue: June 03, 2004
Revision 2: January 20, 2021
ATA System: 5311

SUBJECT: FUSELAGE - Frames and Bulkheads - Body Station 1016 Aft Pressure Bulkhead -
Apex Inspection

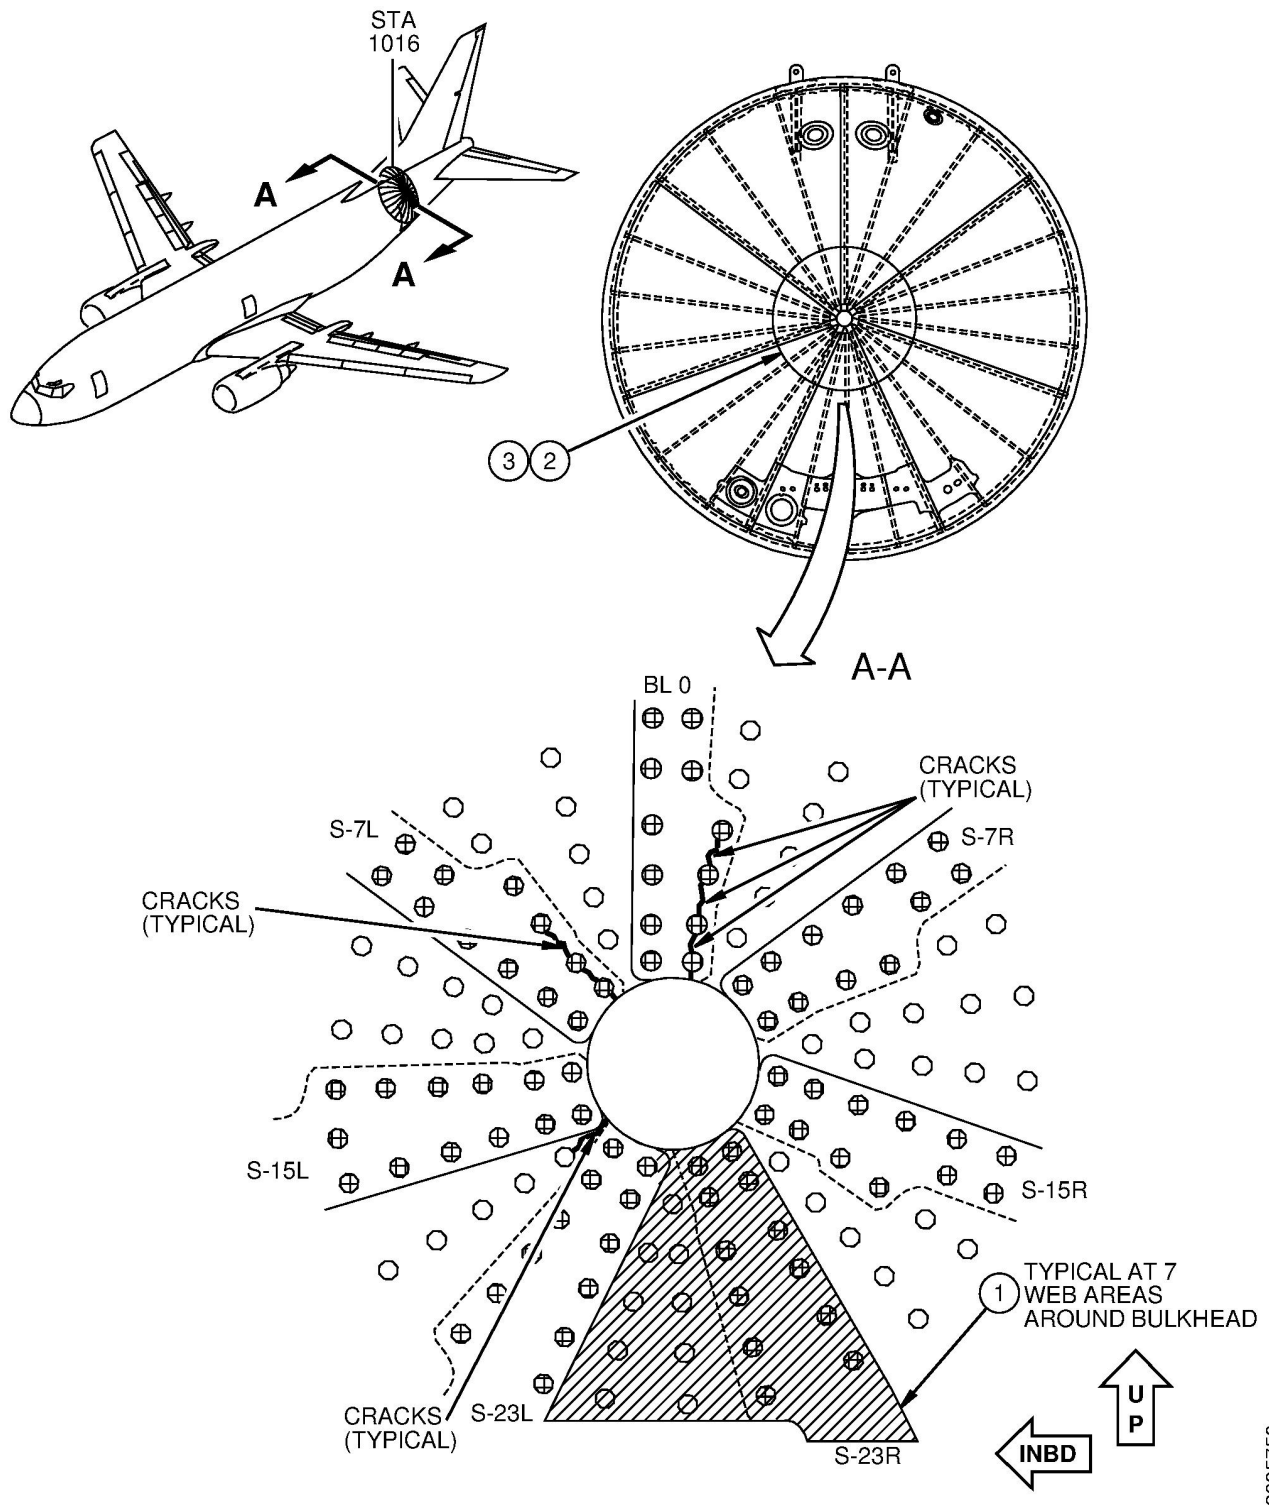
**FIGURE 1: AFT PRESSURE BULKHEAD - WEB LAP SPLICE INSPECTION AREAS
(SHEET 1 OF 2)**

Step	Task	Name	Identification	Qty	More Data
1	Inspect	AFT PRESSURE BULKHEAD WEBS	-	-	(a)
2	Inspect	AFT PRESSURE BULKHEAD WEBS	-	-	(b)
3	Inspect	AFT PRESSURE BULKHEAD WEBS	-	-	(c)
(a) Do a Detailed Inspection on the aft side of the Station (STA) 1016 Aft Pressure Bulkhead (APB) center dome apex gore webs including the web edges, lap splices and outside lap splices for any crack.					
(b) Do a Low Frequency Eddy Current Inspection on the aft side of the Station (STA) 1016 Aft Pressure Bulkhead (APB) for any crack around all hidden web lap splice fasteners in accordance with 737 NDT Manual Part 6, 53-10-64.					
(c) Do a High Frequency Eddy Current Inspection on the aft side of the Station (STA) 1016 Aft Pressure Bulkhead (APB) for any crack around the web fasteners in accordance with 737 NDT Manual Part 6, 53-10-64.

- (a) Contact The Boeing Company for repair instructions and do the repair.

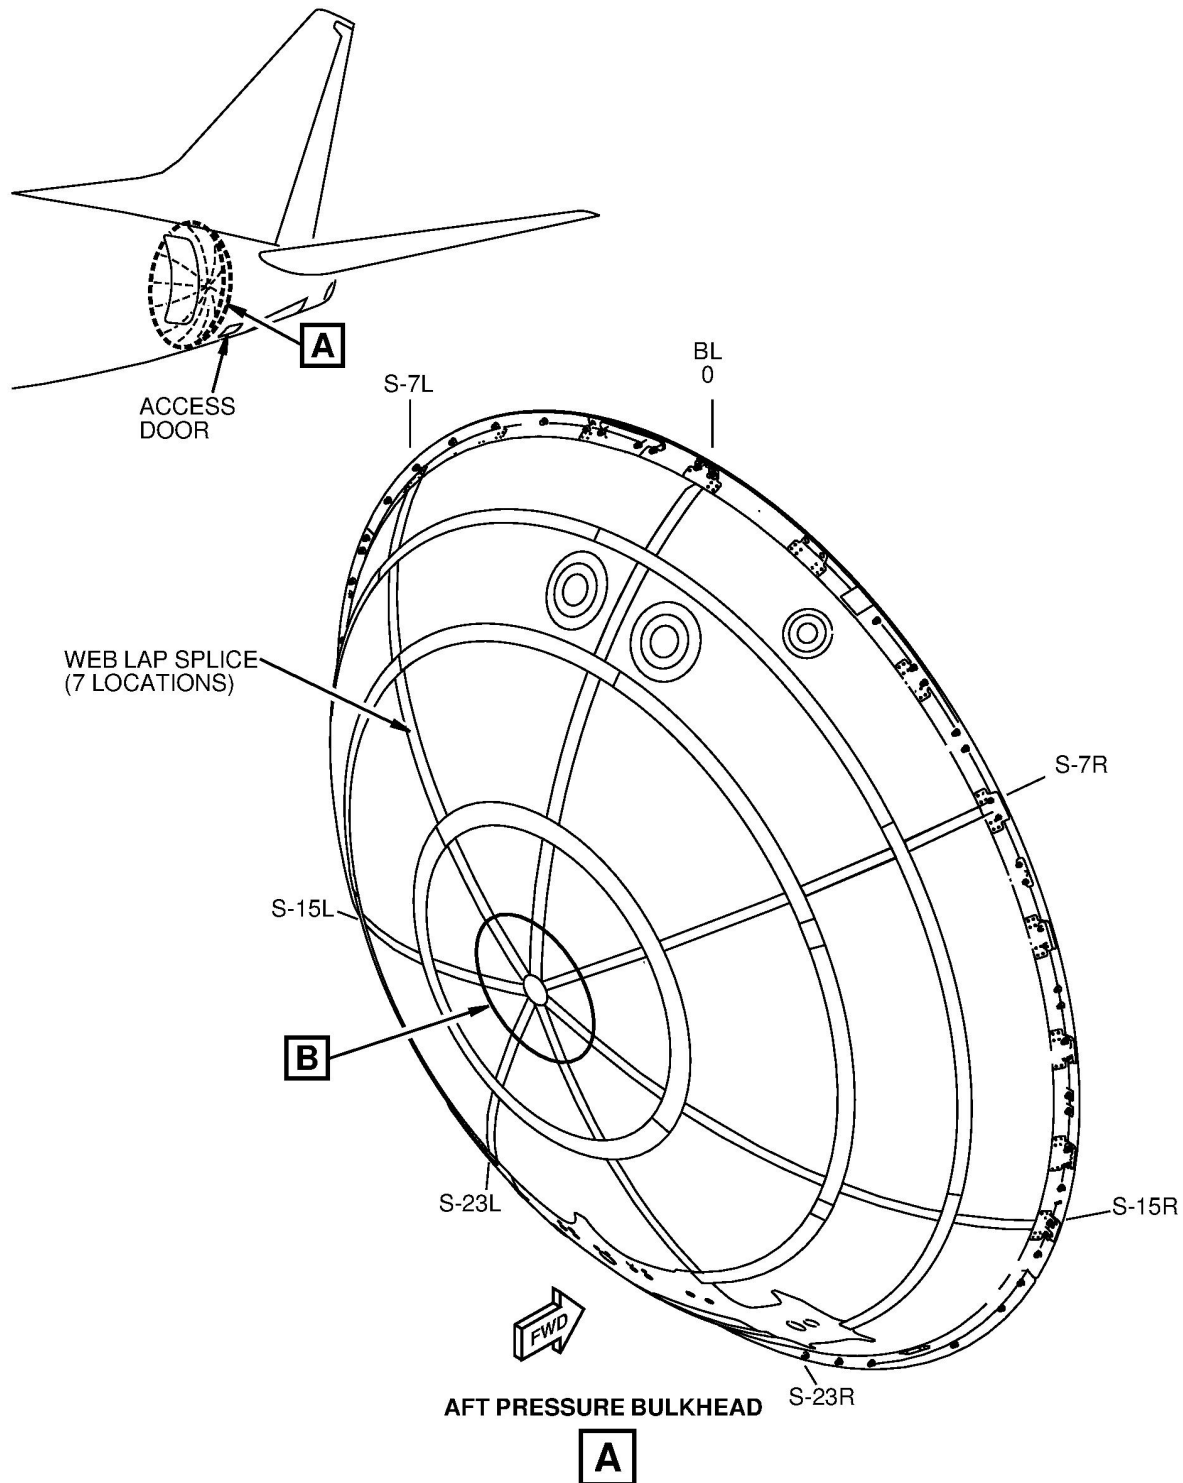
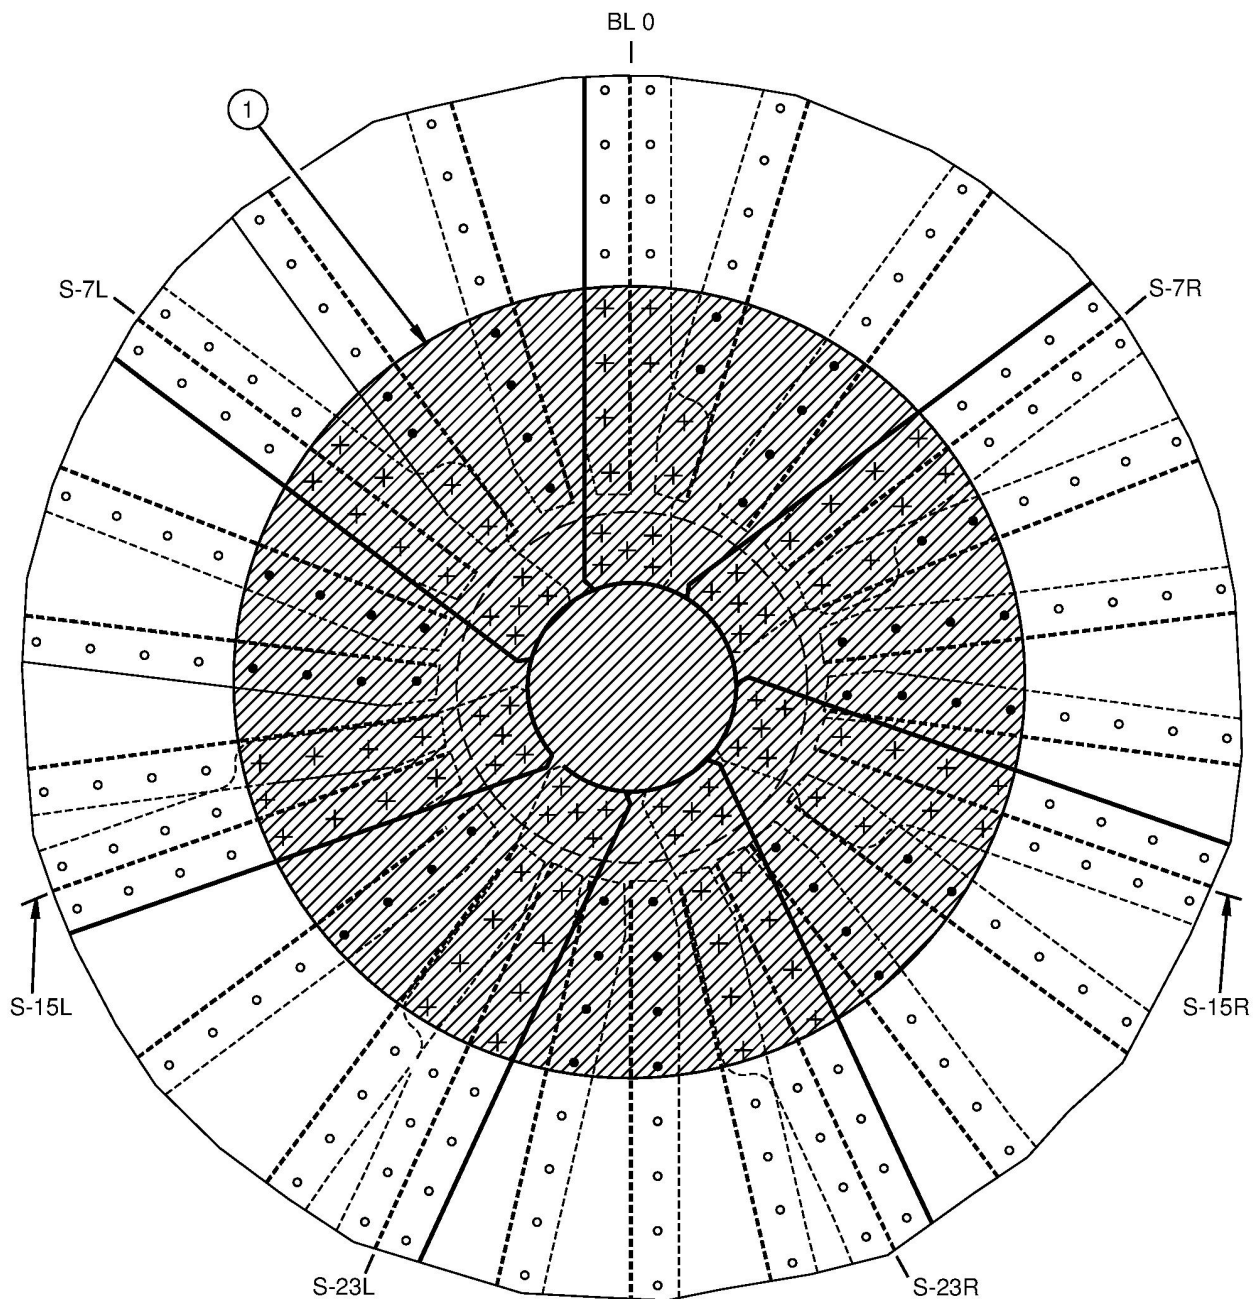
**FIGURE 3: AFT PRESSURE BULKHEAD - GENERAL VISUAL INSPECTION
(SHEET 1 OF 3)**

Step	Task	Name	Identification	Qty	More Data
1	Inspect	AFT PRESSURE BULKHEAD WEBS	-	-	(a)
(a) Do a General Visual Inspection of the aft side of the Station (STA) 1016 Aft Pressure Bulkhead (APB) for any repair.

- (a) Contact The Boeing Company for alternative inspection(s) to this Service Bulletin, and do the inspection(s) and applicable on-condition action(s).

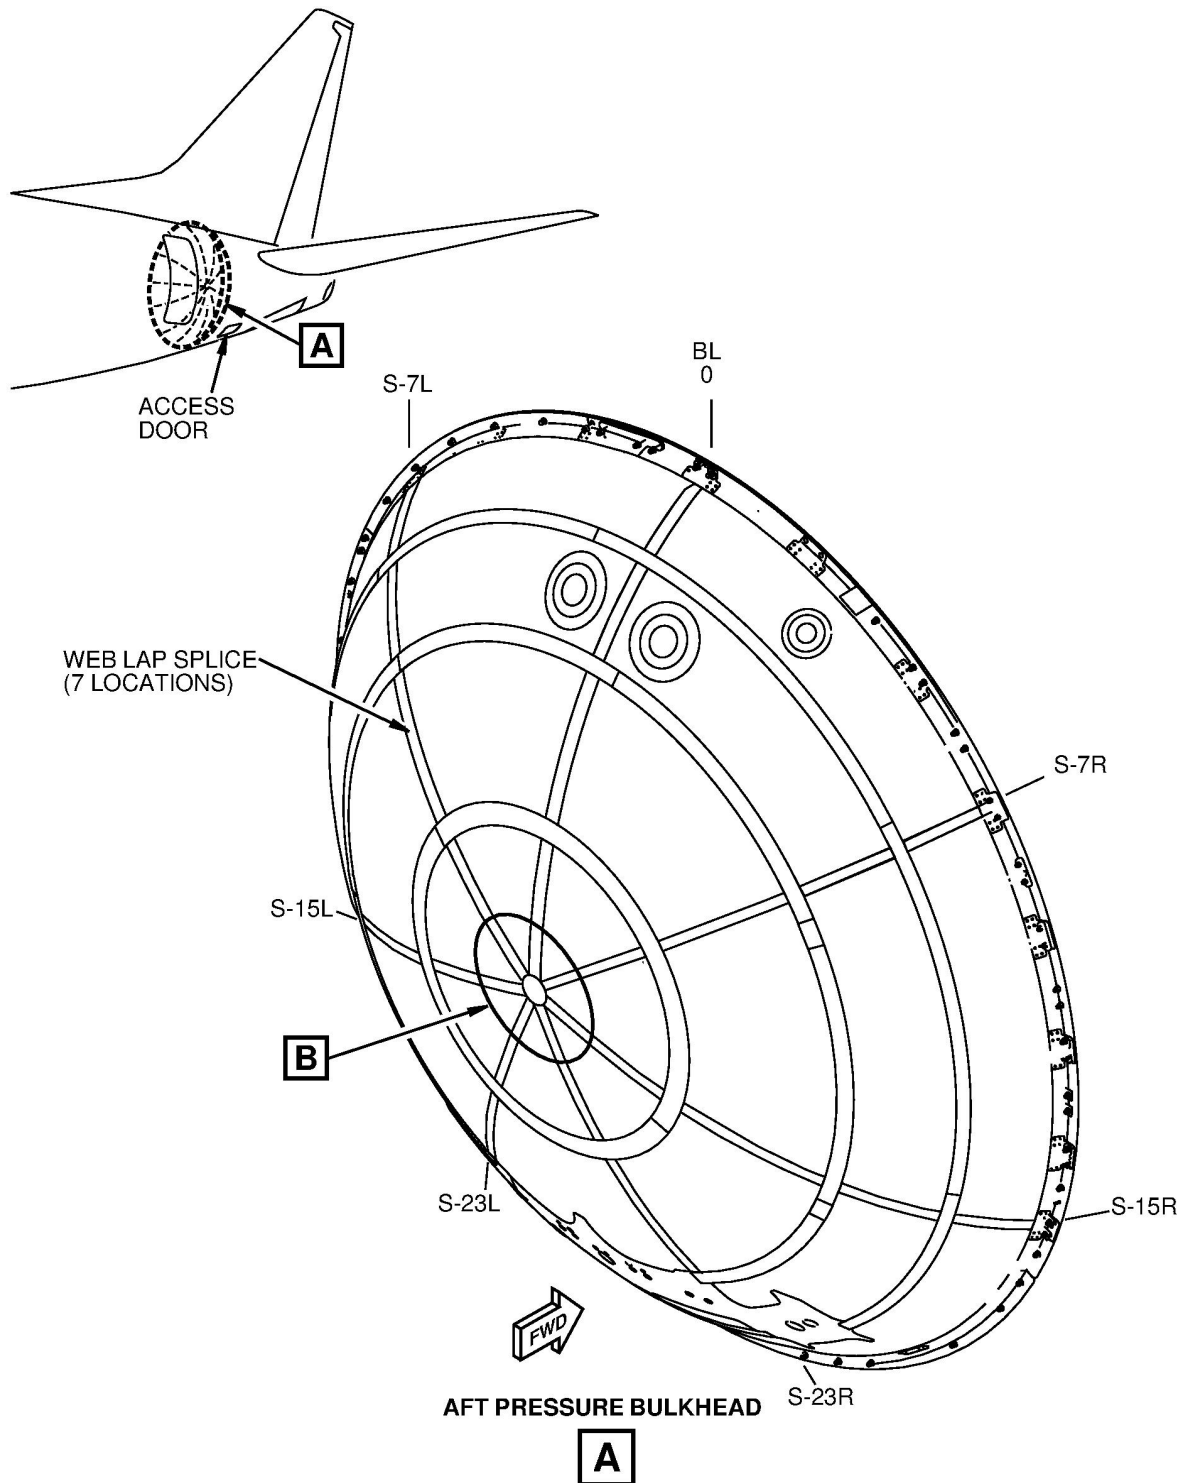
FIGURE 4: AFT PRESSURE BULKHEAD - WEB LAP SPLICE INSPECTION AREAS
(SHEET 1 OF 3)

- (1) Do a Detailed, High Frequency Eddy Current (HFEC) and Low Frequency Eddy Current (LFEC) Inspections of the aft side of the Aft Pressure Bulkhead (APB) for any crack in accordance with FIGURE 4.

- a) Contact The Boeing Company for repair instructions and do the repair.

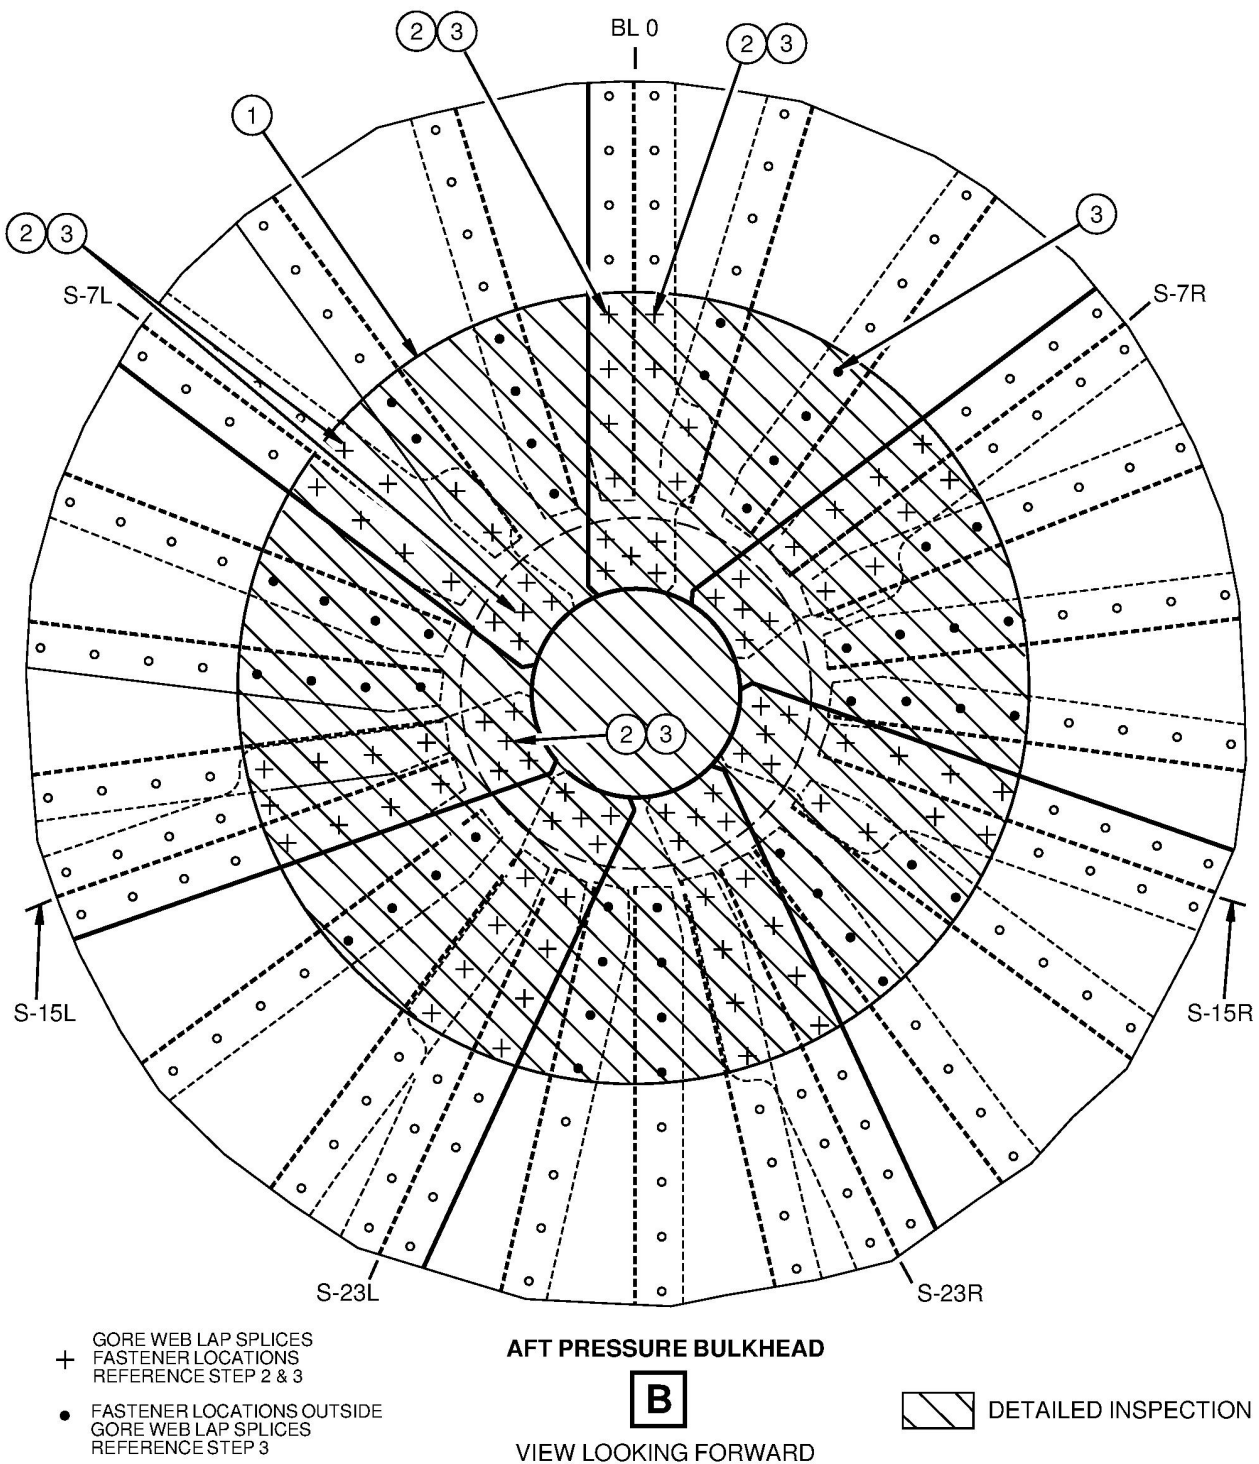
**FIGURE 4: AFT PRESSURE BULKHEAD - WEB LAP SPLICE INSPECTION AREAS
(SHEET 2 OF 3)**

Step	Task	Name	Identification	Qty	More Data
1	Inspect	AFT PRESSURE BULKHEAD WEBS	-	-	(a)
2	Inspect	AFT PRESSURE BULKHEAD WEBS	-	-	(b)
3	Inspect	AFT PRESSURE BULKHEAD WEBS	-	-	(c)
(a) Do a Detailed Inspection on the aft side of the Station (STA) 1016 Aft Pressure Bulkhead (APB) center dome apex gore webs including the web edges, lap splices and outside lap splices for any crack.					
(b) Do a Low Frequency Eddy Current Inspection on the aft side of the Station (STA) 1016 Aft Pressure Bulkhead (APB) for any crack around all hidden web lap splice fasteners in accordance with 737 NDT Manual Part 6, 53-10-64.					
(c) Do a High Frequency Eddy Current Inspection on the aft side of the Station (STA) 1016 Aft Pressure Bulkhead (APB) for any crack around the web fasteners in accordance with 737 NDT Manual Part 6, 53-10-64.
